WEEKLY STATUS REPORT

BCP Project No.:	C224099	EPA Consent Order No.:	CERCLA-02-2017-2021	Date:	6/5/2020
Project Name:	BRT Powerhouse 153 2 nd Street AKA 322 3 rd Avenue, Brooklyn, NY 11215				
General Comments (Week of June 1, 2020): <ul style="list-style-type: none">• All work completed during this reporting period was completed in accordance with the New York State Department of Environmental Conservation (NYSDEC)-approved Site Management Plan (SMP), dated December 2017 and the United States Environmental Protection Agency (USEPA)-approved Amendment to the Remedial Action Work Plan for PCB Cleanup, dated March 23, 2020.• The site received an essential construction determination from the New York City Department of Buildings (NYCDOB) on April 17, 2020. The authorized essential work consists of remedial construction and bulkhead construction as described in the Essential Construction Request prepared by Roux Environmental Engineering and Geology, D.P.C., dated April 17, 2020.• The site received an updated essential construction determination from the NYCDOB on May 19, 2020. The authorized essential work consists of continuing in-process concrete and masonry restoration, and includ

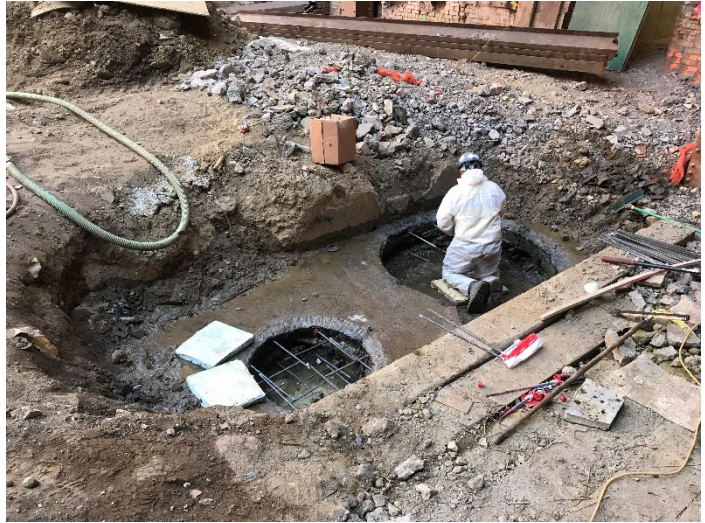
Photo 1 – Facing north, StructureTech New York drills and installs rebar at the TH-SUMP-5 and TH-SUMP-5-Auxiliary openings in preparation for the upcoming structural cap concrete pour.

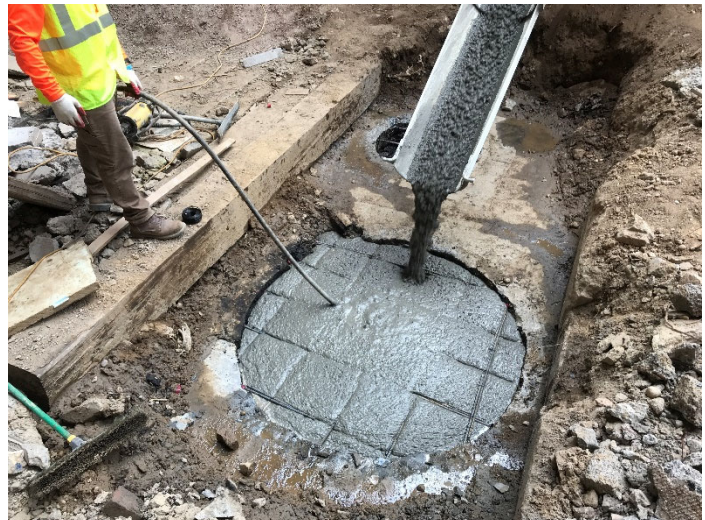
Photo 2 – Facing south, StructureTech New York pours the structural concrete cap at TH-SUMP-5 and TH-SUMP-5-Auxiliary.

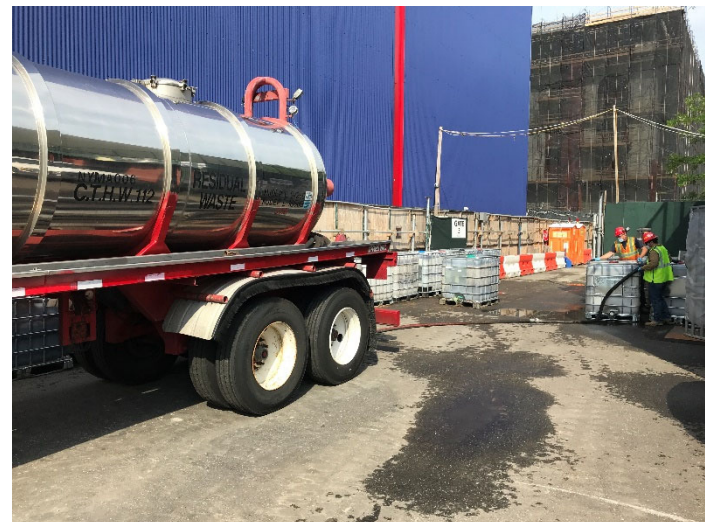
Photo 3 – Facing west, Clean Harbors uses a vacuum trailer truck to remove PCB-contaminated water from the totes generated during the turbine hall sump remediation for offsite disposal.
